Aquifer Guardians in Urban Areas PO Box 15618 San Antonio, Texas 78212

Protecting the Edwards Aquifer

Vulnerability, contamination, effects of development, and inadequacy of engineered controls

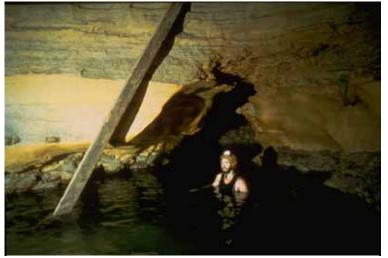
limestone minerals and opened ever-larger holes, channels and caverns. These relatively large openings allow the aquifer to recharge quickly. The cavernous nature of the aquifer also allows rapid water movement within the aquifer. For

Inside the Edwards Aquifer

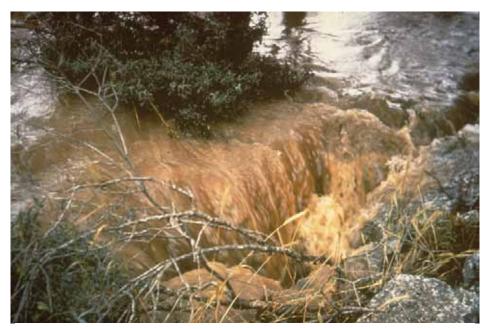
banks. Any activity within these watersheds that taints or contaminates runoff will contaminate water within the Aquifer. Within the recharge zone, the aquifer is fed both from streams and from direct infiltration through karst

Stormwater entering Hills and Dales Cave

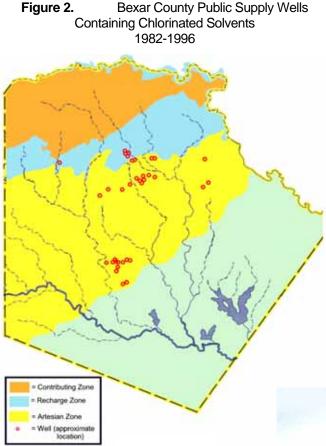
Chlorinated solvents appear in numerous wells in Bexar County (see figure 2). These man-made substances are there for only one reason, we put them there. Even though the central portion of Bexar County has been developed much longer than the northern portion of the county, most solvents have been found toward the north, near and on the recharge zone, the most vulnerable portion of the aquifer.

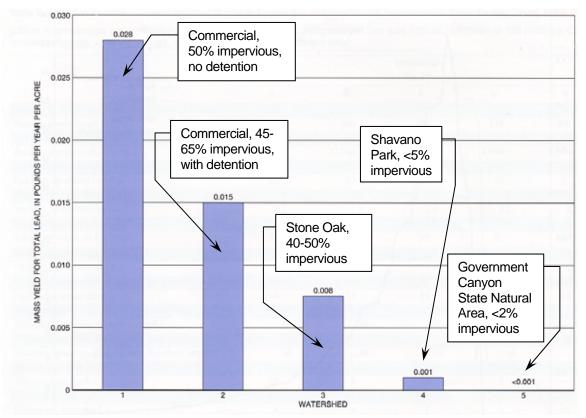
Figure 3. Annual mass yields for total lead by watershed, Bexar County, Texas, 1997.

With higher impervious cover, more pollutants are generated and carried into stormwater runoff. A study⁶ conducted in Bexar County shows that higher impervious cover levels generally lead to higher mass yields of lead and higher concentrations of fecal coliform, toxic metals, pesticides and other contaminants. The study compared stormwater runoff from commercial developments near DeZavala and IH-10 to stormwater runoff from Shavano Park, Stone Oak, and Government Canyon. As Figure 3 shows, mass yields for lead were far higher in the watersheds with high impervious cover levels.

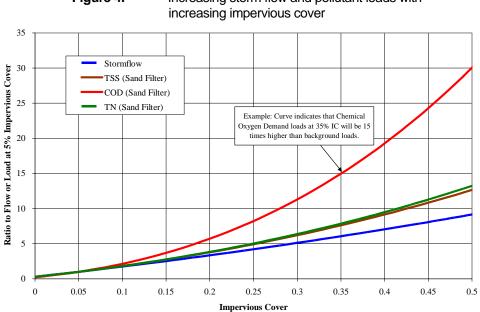
Figure 4. Increasing storm flow and pollutant loads with

Figure 4 shows estimated pollution increases in storm runoff as impervious cover increases due to development. These relationships are based on data from storm runoff monitoring in Central Texas and are consistent with results from many similar studies around the United States. The figures show that with even modest levels of imperviousness, pollutant loads increase by 5 to 12 times that of an undeveloped site.

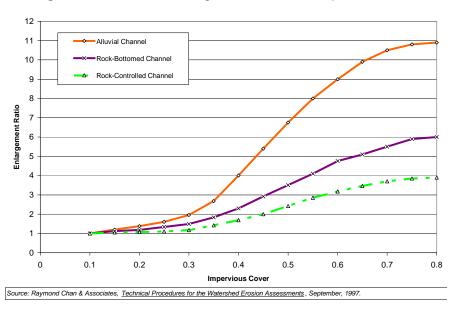
Figure 5.
 Stream enlargement ratio versus impervious cover

pollutants introduced by this runoff suffocate and contaminate stream ecosystems, and eliminate the natural pool and riffle sequences critical to fish and wildlife. Enlarging channels destroy tree root support and eventually these large trees fall and die. Figure 5 illustrates the effect of impervious cover on the size of stream channels.

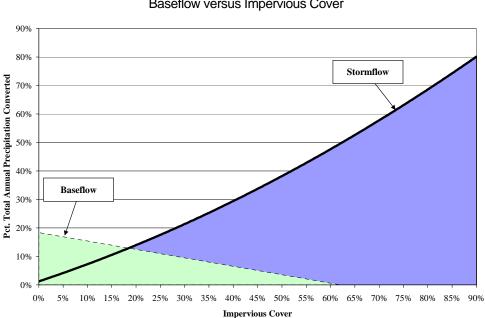
Figure 6.

Percent of Precipitation Converted to Stormflow and Baseflow versus Impervious Cover

Figure 6 shows how baseflow drops and storm runoff increases as imperviousness increases. Impervious surfaces covering about 30% of a site reduce baseflow volumes by one half. At 60% imperviousness, virtually 100% of the baseflow is eliminated. Even if we were to eliminate 100% of the pollutant loads in storm runoff, development still diminishes baseflow volumes, which in turn diminishes the amount of aquifer water available.

Baseflow is water in creeks and rivers between storm runoff events. It provides most of the Edwards Aquifer recharge in the Barton Springs Zone and likely in the San Antonio Edwards as well. Baseflow loss translates directly, therefore, into a reduction in available aquifer water. The loss of baseflow also radically alters the natural character of the stream and reduces the viability of wetlands and aquatic habitat.

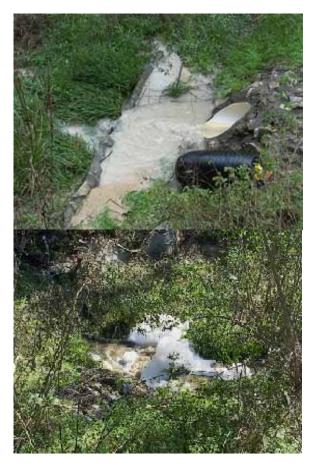
The photograph to the left shows that the sand filtration basin for a Sam's Club was clearly overloaded with sediment during construction.

While finishing the concrete floors, however, chemicals from the finishing process were

released into the filtration basin. In

addition, someone removed a plug (photograph below) that would have kept these chemicals from flowing out of the basin and into a creek connected to known Edwards recharge features.
